VERIFICATOR	EXIGENTA "A"	REFERATNR.	DATA
VERIFICATOR	CERINTA "C"	REFERATNR.	DATA
VERIFICATOR	EXIGENTA "A"	REFERATNR.	DATA
S.C. UTILIDEEA S.R.L.		BENEFICIAR: Valia Florin Mihai	
16715283		AMPLASAMENT: Municipiul Craiova, strada Melodiei nr. 100.	
		Lot cu NC 246220 U.A.T. Craiova, judetul Dolj	
		PR. NR. 1310021	
		FAZA: Arhitectural D.T.A.C.	
		PLANSĂ: A 10

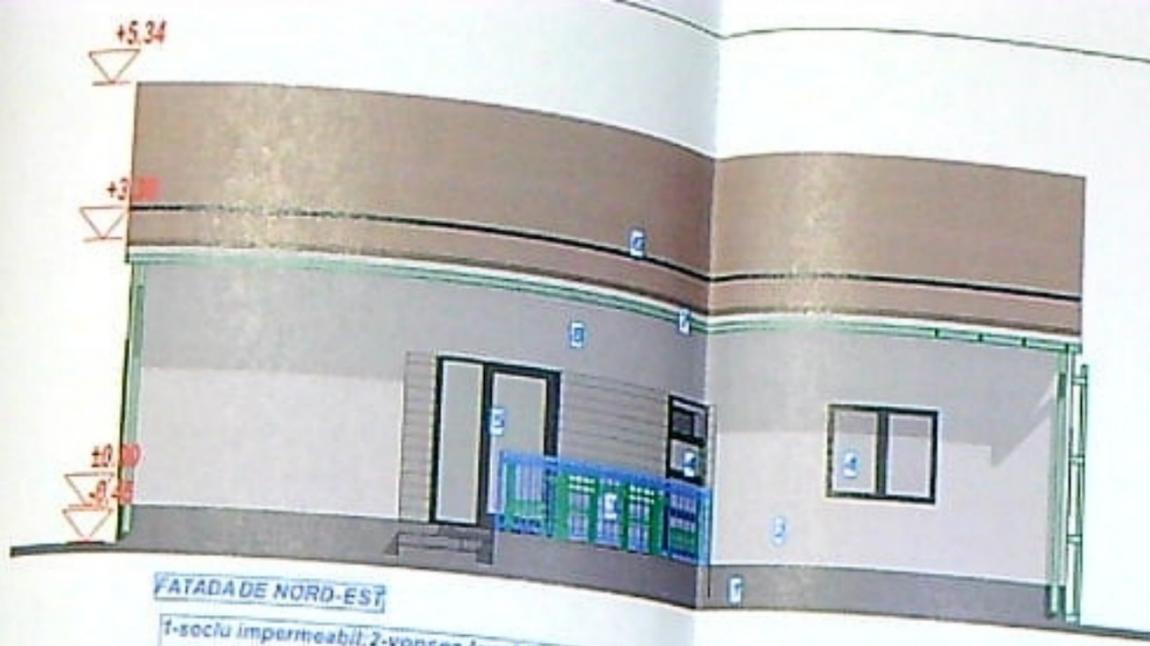
FATADA DE NORD-EST

1-soclu impermeabil; 2-vopsea lavabila alba; 3-balustrada metalica; 4-fereastră PVC nuanta lemn cu geam termopan; 5-usa de acces in cladire din PVC nuanta lemn cu geam termopan; 6-parazapezi; 7-jgheab; 8-burlan

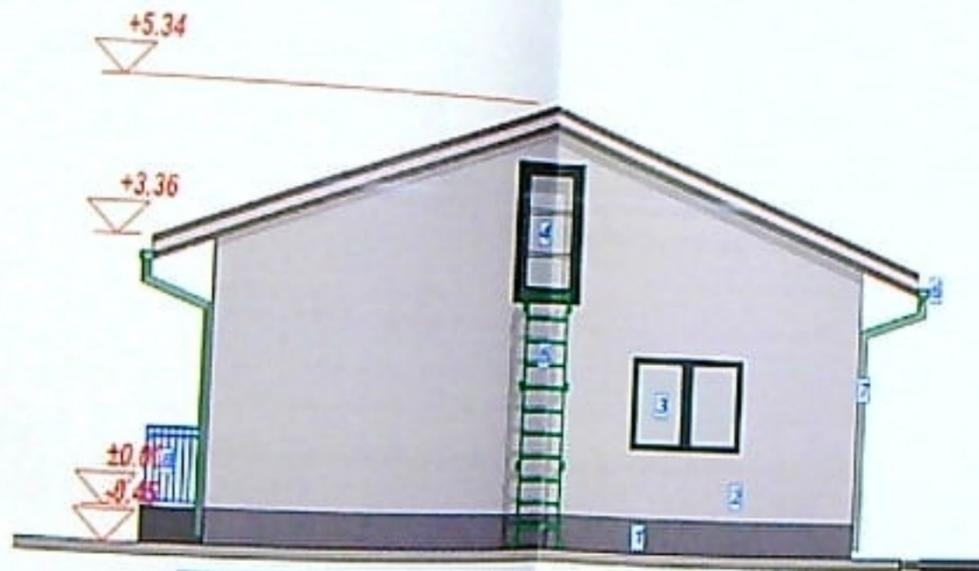
FATADA DE NORD-VEST

1-soclu impermeabil; 2-vopsea lavabila alba; 3-fereastră PVC nuanta lemn cu geam termopan; 4-usa de acces la pod; 5-scara metalica de acces la pod; 6-jgheab; 7-burlan; 8-balustrada metalica

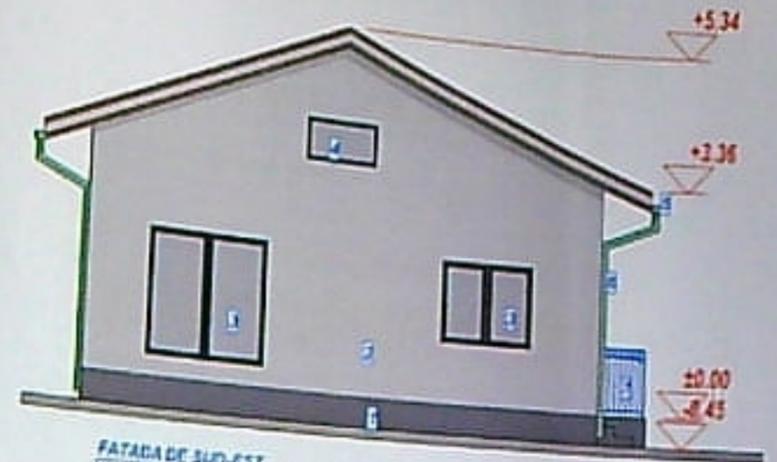
FATADA DE SUD-EST

1-soclu impermeabil; 2-vopsea lavabila alba; 3-fereastră PVC nuanta lemn cu geam termopan; 4-luminator pod din PVC cu geam termopan; 5-jgheab; 6-burlan; 7-balustrada metalica

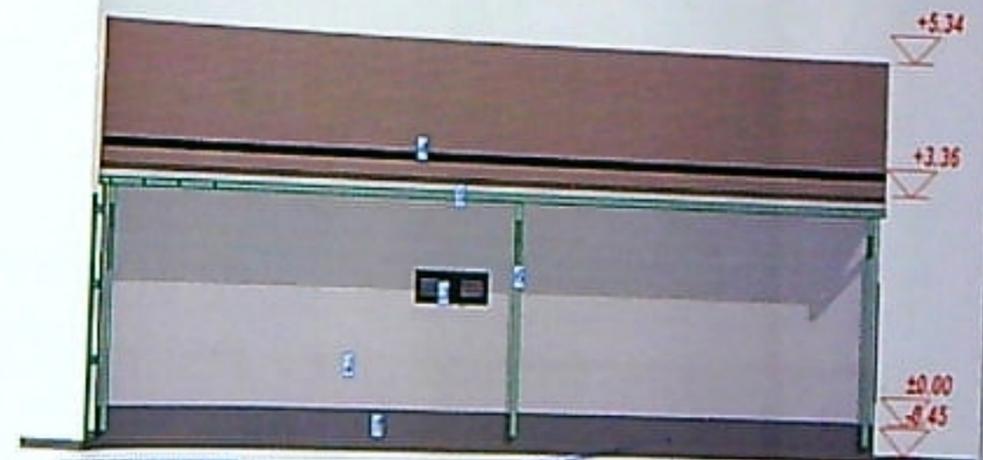
FATADA DE SUD-VEST

1-soclu impermeabil; 2-vopsea lavabila alba; 3-fereastră cu trafic opac; 4-parazapezi; 5-jgheab; 6-burlan
